A Workable, Lasting Solution for Water Losses through Leaking Water Pipes

Introduction

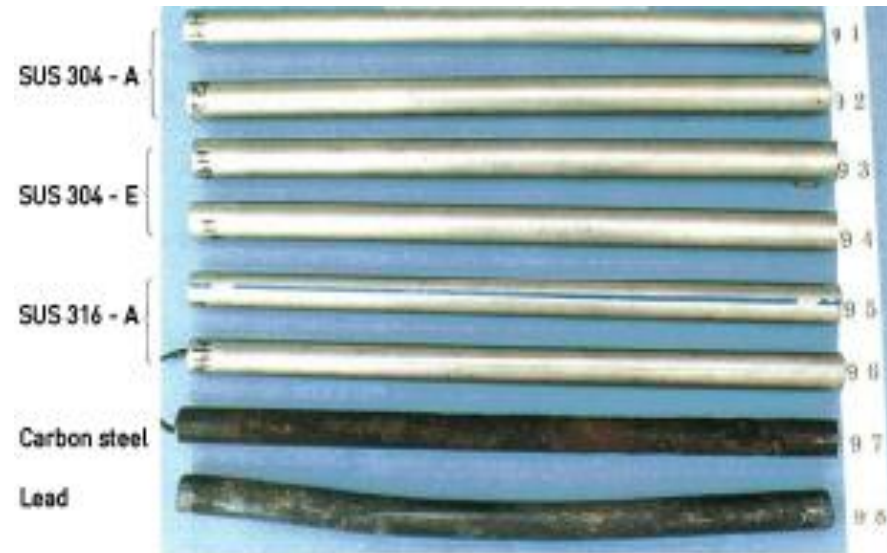
1. Koshiro city, test No. H; after acid pickling

- Tokyo tested carbon steel, copper, lead and grades 304 and 316 stainless steel, burying them at 10 sites, for 10 years
- Tokyo has high concentrations of Cl^- and SO_4^{2-} , and requires a strong resistance to corrosion
- Stainless steel performed best for corrosion resistance and 316 outperformed 304

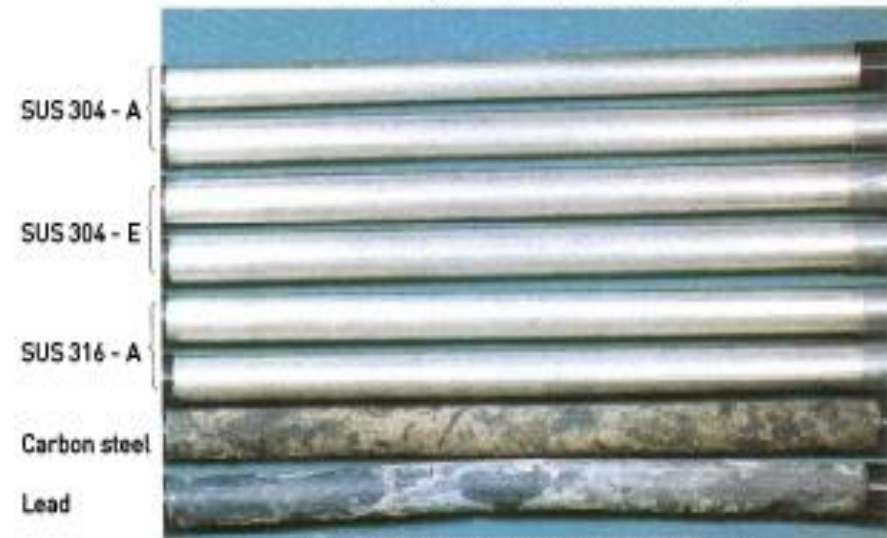
2. Kuwana city, test No. P; after acid pickling

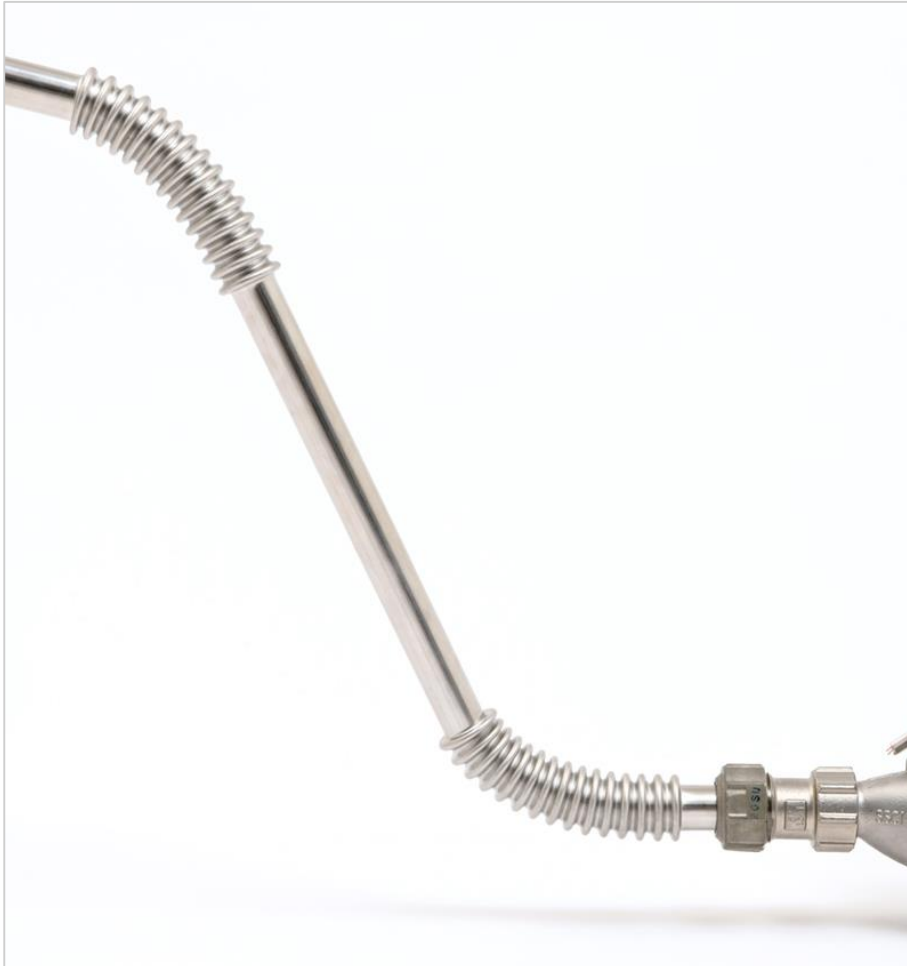
Corrugated Stainless Steel Pipes

- Most leaks were found at joints
- Corrugated pipes could be bent on-site thereby improving handling and reducing joints
- They could remain flexible after installation, providing resistance to seismic shocks

- Tested corrugated stainless steel pipes from 1991 to 1998 and introduced them from 1998
- They first used bronze fittings but discovered corrosion at the joints. They changed to stainless steel fittings
- Stainless steel pipes reduced the number of leaks; reduced maintenance; improved water quality; and demonstrated a resistance to seismic activity, thus assuring fewer injuries and continuous water supply
- No evidence of chemical residues inside the pipes
